Plainview Road / Patchen Woods Subdivision Stormwater Study

BT Engineering, Inc.

March 29, 2011

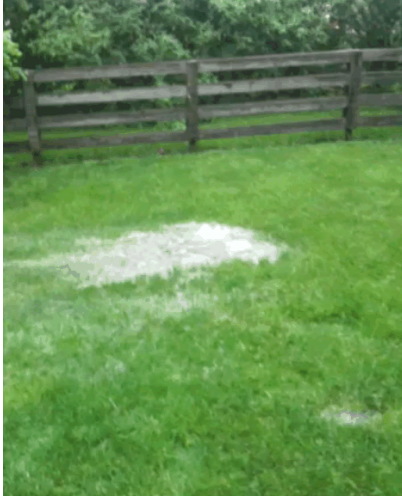
SSO @ Rear of 405 Plainview Road

- Sanitary cross connections with storm sewers should be physically disconnected. It has been reported via Lex-Call and documented via emails that cross connections are evident by smoke tests in the area.

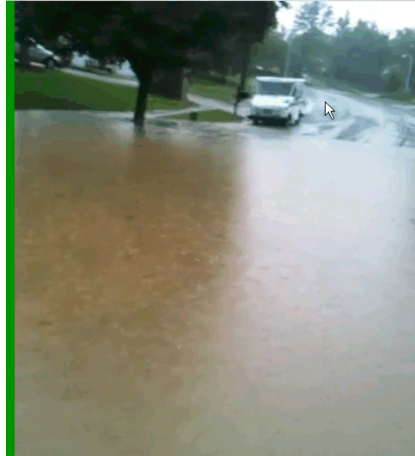
Street Flooding @ Front of 401 & 405 Plainview Road

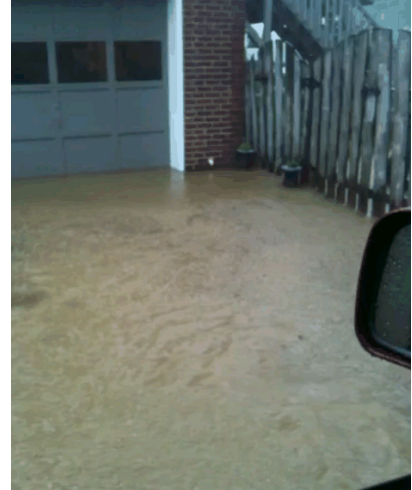
Home Flooding @ 405 Plainview Road

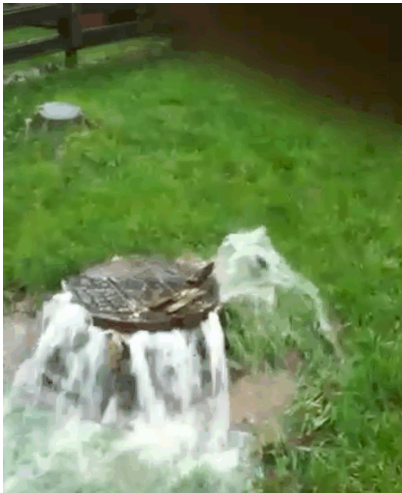
SSO @ Rear of 405 Plainview Road

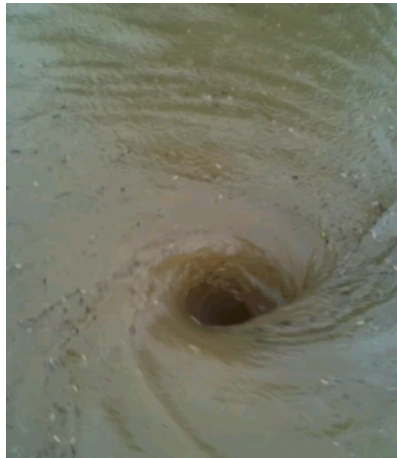
Street Flooding @ CB A-4 in front of 401 Plainview Road

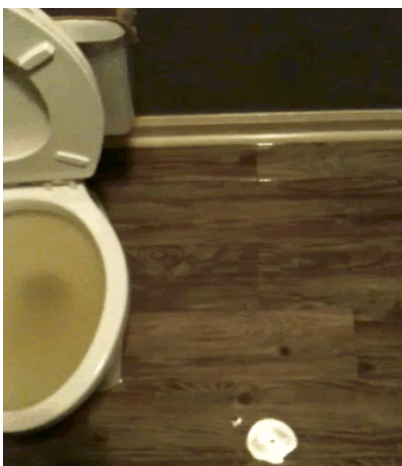
Basement Toilet & Bathroom @ 405 Plainview Road

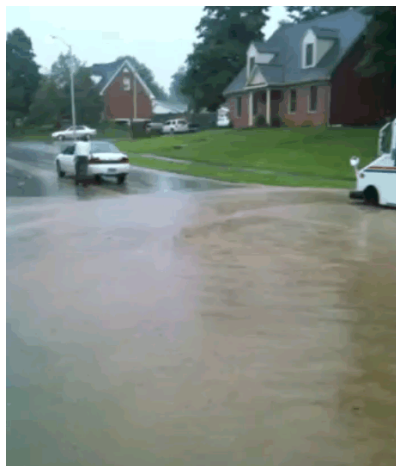
Street Flooding @ Front of 401 & 405 Plainview Road

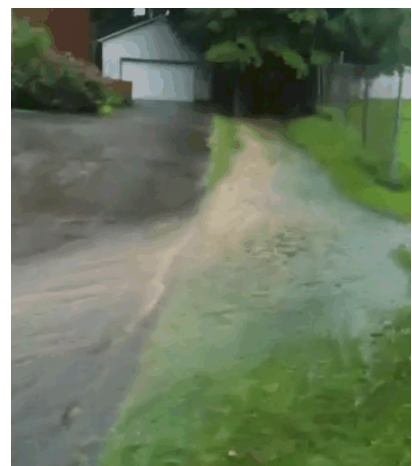
Drainage Swale @ West Side of 396 Plainview Road

- Construction of a storm sewer inlet and pipe at the rear and side of the property of 396 Plainview Road. The proposed downstream storm sewer pipe would then run along the west property line of 396 Plainview Road and outlet into the storm sewer system in front of 405 Plainview Road. .
- Spot grading within the upstream rear yards of 420, 424, 428, 432 Plainview Road and 489, 481, 477, 473 Channing Way.
